Optima® ETF-80/ETF-880

PARTS LIST—ETF-80 AND ETF-880 FAUCETS

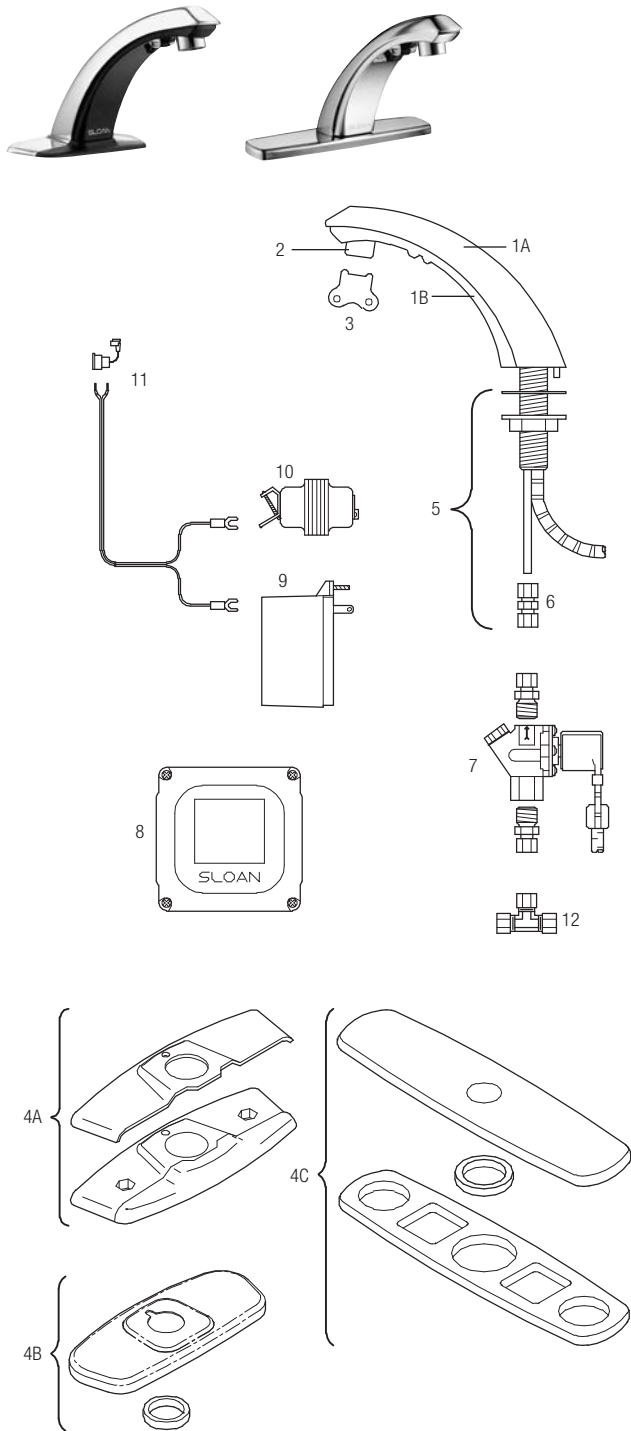
Item No.	Code No.	Part No.	Description
1A.	0305613	ETF-250-A	Faucet/Sensor Assembly (ETF-80)
	0365054	ETF-625-A	Faucet/Sensor Assembly (ETF-880)
1B.	3365523	ETF-631-A	Sensor Assembly Only (for Faucets manufactured after 10/2003, identified by an all white Sloan name on throat plate) (ETF-80). For ETF-80 faucets prior to 10/2003 (identified by a white and red Sloan name on throat plate) sensor assembly discontinued. Use ETF-250 faucet/sensor assembly.
	0365016	ETF-628-A	Sensor Assembly Only (ETF-880)
	3365548	ETF-1031	Repair Kit Throat Plate and Sensor (ETF-880)

2.	3365091	ETF-1021-A	0.5 gpm (1.9 Lpm) Spray Head with Key (female thread)
	3365090	ETF-1022-A	2.2 gpm (8.3 Lpm) Aerator Spray Head with Key (female thread)
	3365161	ETF-1028-A	1.5 gpm (5.7 Lpm) Laminar Flow Spray Head with Key (female thread)

3.	0305927	ETF-435	Replacement Key ONLY
4A.	3365466	ETF-295-A	4" (102 mm) Centerset Trim Plate Kit for Faucet (Faucet Only) includes two (2) Nuts, two (2) Hex Screws, two (2) Flat Washers, Single Hole Cover Plate, and CP Base Plate (ETF-80)
—	3365467	ETF-299-A	4" (102 mm) Centerset Trim Plate Kit for Faucet with Optional Mixing Valve includes two (2) Nuts, two (2) Hex Screws, two (2) Flat Washers, Dual Hole Cover Plate, and CP Base Plate (ETF-80)
4B.	3365473	ETF-662-A	4" (102 mm) Centerset Trim Plate Kit (CP) (ETF-880)
4C.	3365024	ETF-510-A	8" (203 mm) Centerset Trim Plate Kit includes two (2) Finger Nuts, two (2) Washer Gaskets, two (2) Fender Washers, Base Gasket, Back-up Spacer and CP Single Hole Trim Plate Assembly (CP) (ETF-880)

5.	0305626	ETF-290-A	Faucet Mounting Kit includes Rubber Gasket, Mounting Washer, Mounting Nut, and 4439071 Compression Fitting Connector
6.	0305736	ETF-297	1/4" to 3/8" Compression Fitting Connector

7.	0305849	ETF-370-A	24 VAC Solenoid Valve Assembly includes 18" (457 mm) armored Cable and two (2) Terminal Housings
	3305577	ETF-1009-A	Solenoid Valve Repair Kit includes Replacement Filter, Guide, Armature Spring, Diaphragm and Washer
	3365676	ETF-437-A	Single Solenoid Supply Kit includes, two (2) Compression Fittings

8.	3365000	ETF-450-A	Control Module Assembly includes splashproof Junction Box and Junction Box Mounting Kit
9.	0365534	ETF-233	120V/35VA Plug-In Transformer

10.	0345370	EL-248-40	24V/40 VA Box Mount Transformer
11.	0365001	ETF-458-A	Input Power Cable (Transformer to Control Module) includes Strain Relief and two (2) Terminal Crimp Connectors

12.	3365461	ETF-617-A	Bak-Chek® "T" Assembly
—	3305560	ETF-1006-A	Repair Kit for old-style ETF-80 Faucets (manufactured before 1992) includes Hex Screw, 5/64" Hex Wrench, Cable Assembly, Hose Clamp, 5-connector Housing, Key for Spray Heads, Access Plate/Sensor Assembly, and Control Module Assembly — OBSELETE

- C. There is a short in the Sensor.
Replace sensor. Refer to individual faucet parts diagram for appropriate sensor assembly. Note: GREEN LED may illuminate immediately after sensor disconnection.
- D. There is a short in the solenoid or solenoid cable.
Replace ETF-370-A solenoid.

- J. Sensor range is set too long and is detecting the sink.
Reduce sensor detection range.
- K. Sensor is faulty.
Replace sensor. Refer to individual faucet parts diagram for appropriate sensor assembly.

- L. Sensor range is set too short.
Increase sensor detection range.
- M. Sensor is faulty.
Replace sensor. Refer to individual faucet parts diagram for appropriate sensor assembly.
